### April 2023 Service Bulletin

Titan Logix has released firmware updates for the TD100 Transmitter and the Finch II (Finch II, Finch II-W, Finch II-6W) Display. The firmware updates will enable the following new features:

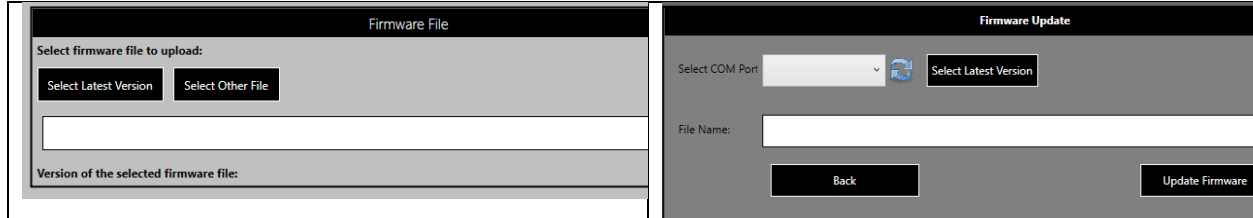
The latest firmware files for the TD100 Transmitter, Finch II display and SensorLink can be downloaded from the Titan Logix website <https://www.titanlogix.com/support/downloads/> or through SensorLink by clicking on “Select Latest Version”.

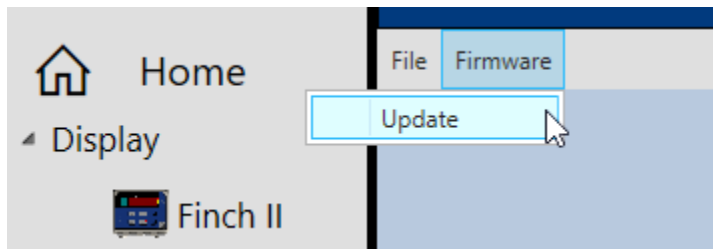
Click on Firmware \ Update from the top menu to begin the upgrade.

The Firmware Upgrade screen will outline the steps required to update the firmware.

To upgrade the firmware on the Finch II, connect the display with the programming cable to a laptop with SensorLink 5.5.1 or higher. Open SensorLink and click on Finch II in the left menu.
